Lighting Upgrade Case Study

GILBARCO
VEEDER-ROOT

Energy Efficient Lighting Case Study – Gilbarco Auburn

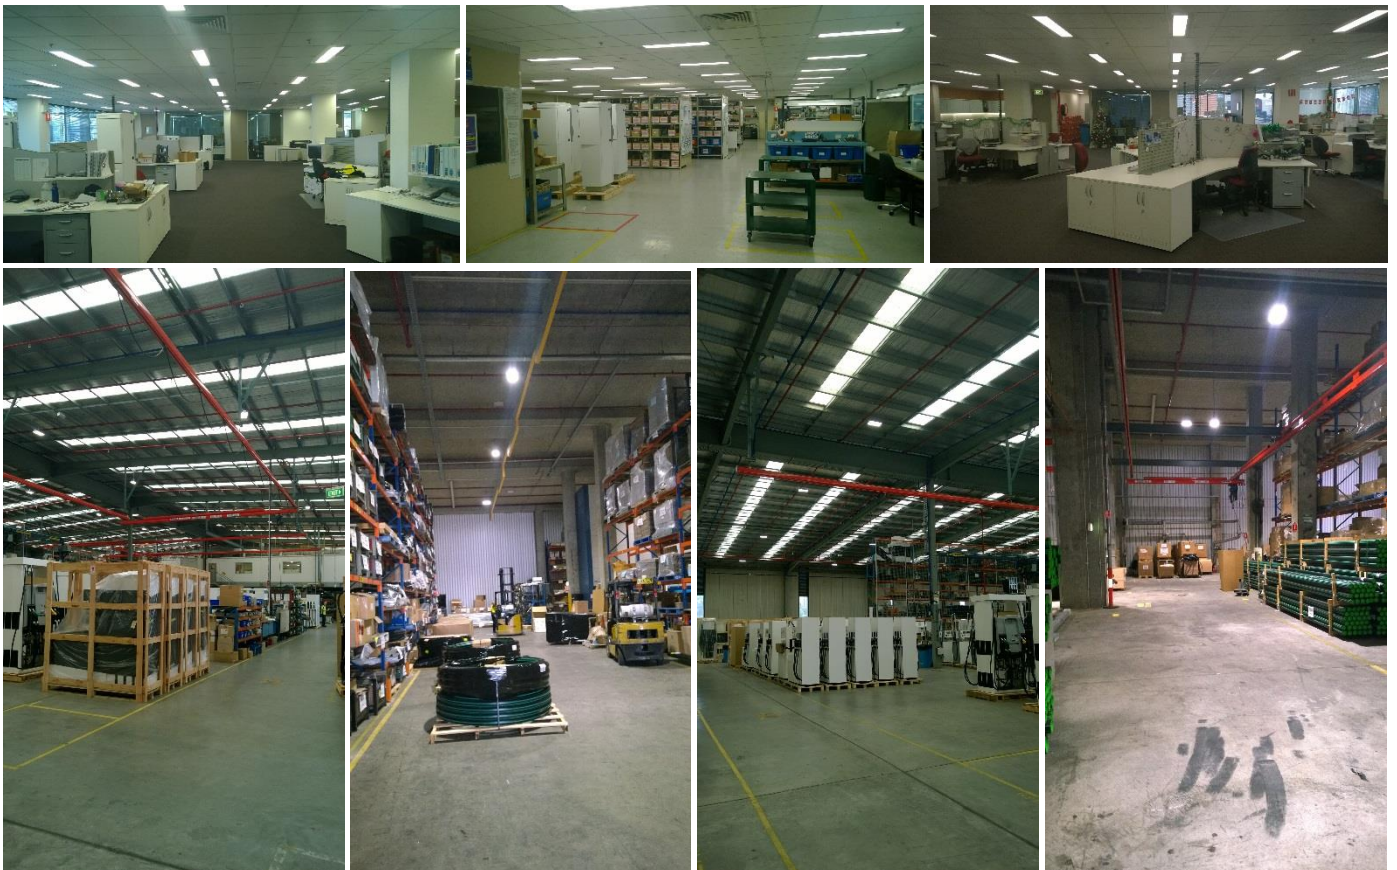
Offices		
	Existing Lighting	Upgrade Lighting
Photo	 	 
Lamp Type	Twin 4' T8 Fluorescent	LED Panel
Quantity	578	578
Consumption	92W/56W	32W/20W
Operational Hours	2,282 p/a	2,282 p/a
Maintenance	8,000 hrs (3.5 yrs)	30,000 hrs (13+ yrs)
Energy Cost p/a	\$35,897	\$11,846

Upgrades commenced mid-December 2014 replacing the existing Twin T8 fluorescent office T-bar ceiling troffers with LED panel lighting. The lighting in other areas of the site include, factory and warehouse hi bays, fluorescent task lighting, and down lights.

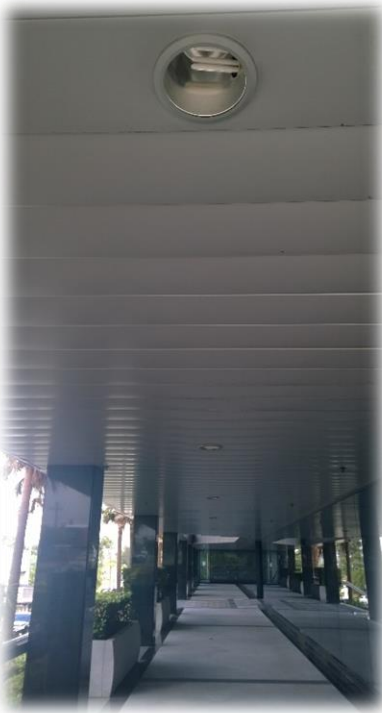
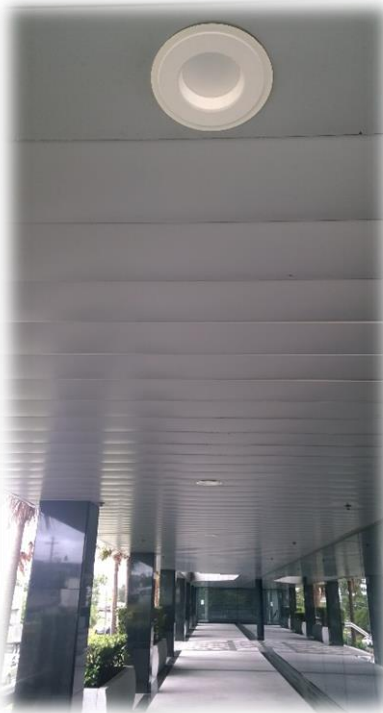
Down Lights		
	Existing Lighting	Upgrade Lighting
Lamp Type	35W Halogen	LED Down Light
Consumption	35W	8.5W
Quantity	28	28
Lamp Type	CFL Down Light	LED Down Light
Photo

Consumption	50W	10W
Quantity	28	28
Operational Hours	2,282 p/a	2,282 p/a
Maintenance	8,000 hrs (3.5 yrs)	30,000 hrs (13+ yrs)
Energy Cost p/a	\$1,670	\$348

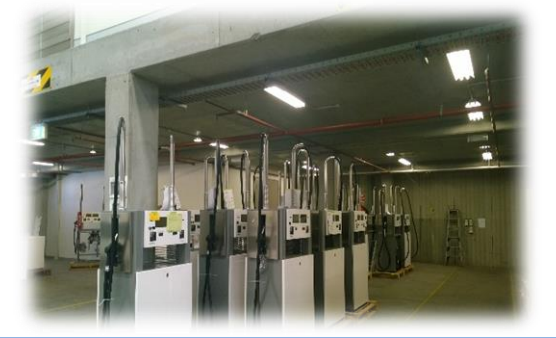
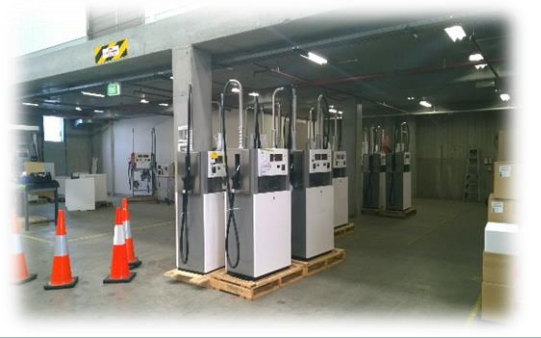
Under Mezzanine & Fluorescent Batten Lighting		
	Existing Lighting	Upgrade Lighting
Lamp Type	Twin 4' T8 Fluorescent	Single Reflector 4' T5 Fluorescent
Photo

Consumption	92W/56W	32W/16W
Quantity	98	98
Operational Hours	2,282 p/a	2,282 p/a
Maintenance	8,000 hrs (3.5 yrs)	20,000 hrs (10+ yrs)
Energy Cost p/a	\$5,263	\$2,214

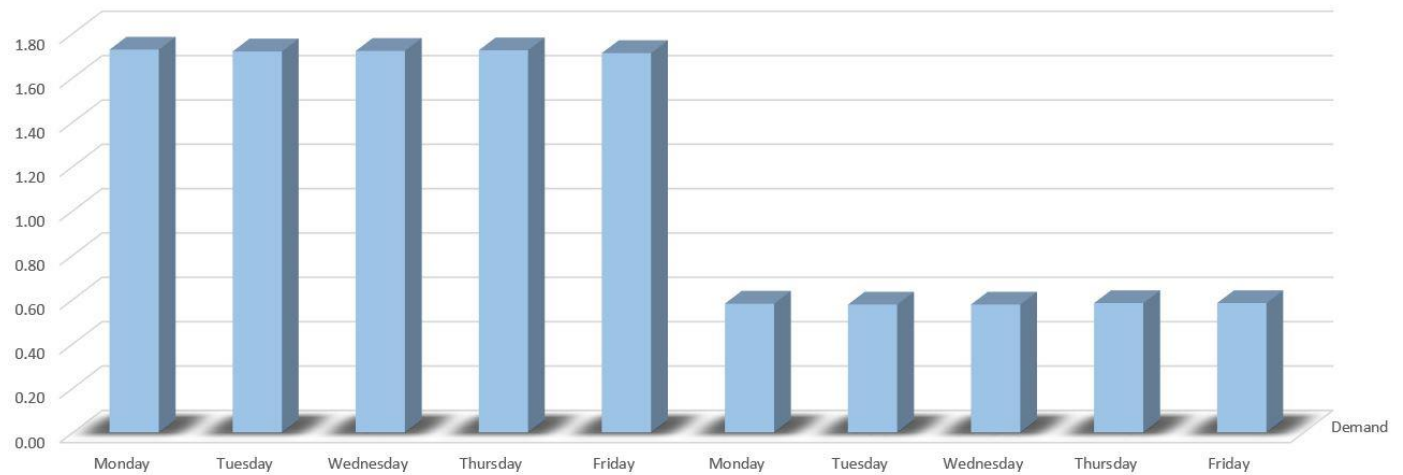
Office Consumption

One section metered was the office lighting, where twin T8 Fluorescent T-bar troffers were replaced with LED Panel Lighting. This is a typical scenario for Commercial office lighting and is a good indication of the typical results that can be achieved in energy reduction, and shows a 66% reduction in electricity consumption.

Sample circuits have been logged to measure the consumption of electricity before and after upgrading, and the result are shown on Page 5.

Meters were installed on two sample circuits on site, in the office and warehouse.

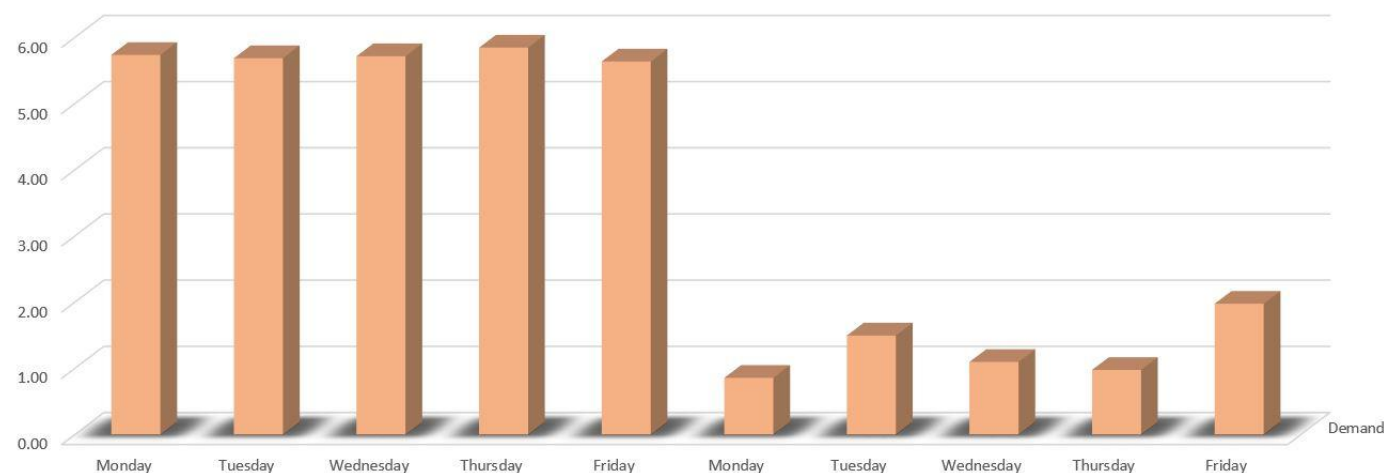
Warehouse Consumption

Another section of lighting metered was in the main factory. Here 400W Metal Halide, and Mercury Vapour Hi Bays were replaced with 150W LED high bays suspended at around 8m high. This section also included the addition of Daylight detection sensors.

This is a typical upgrade for industrial factory and warehouse buildings, and reflects results that can be achieved in most situations, showing a 78% reduction after the first data reading. This result will improve on average over time due to weather conditions over the time of metering.
